January 6, 2012  
Project 2010.0177

**Subject: Cumulative Assessment of Fault Hazard Data in Downtown Hollister  
Summary Letter Report and GIS Map Transmittal  
Downtown Redevelopment Area  
Hollister, California**

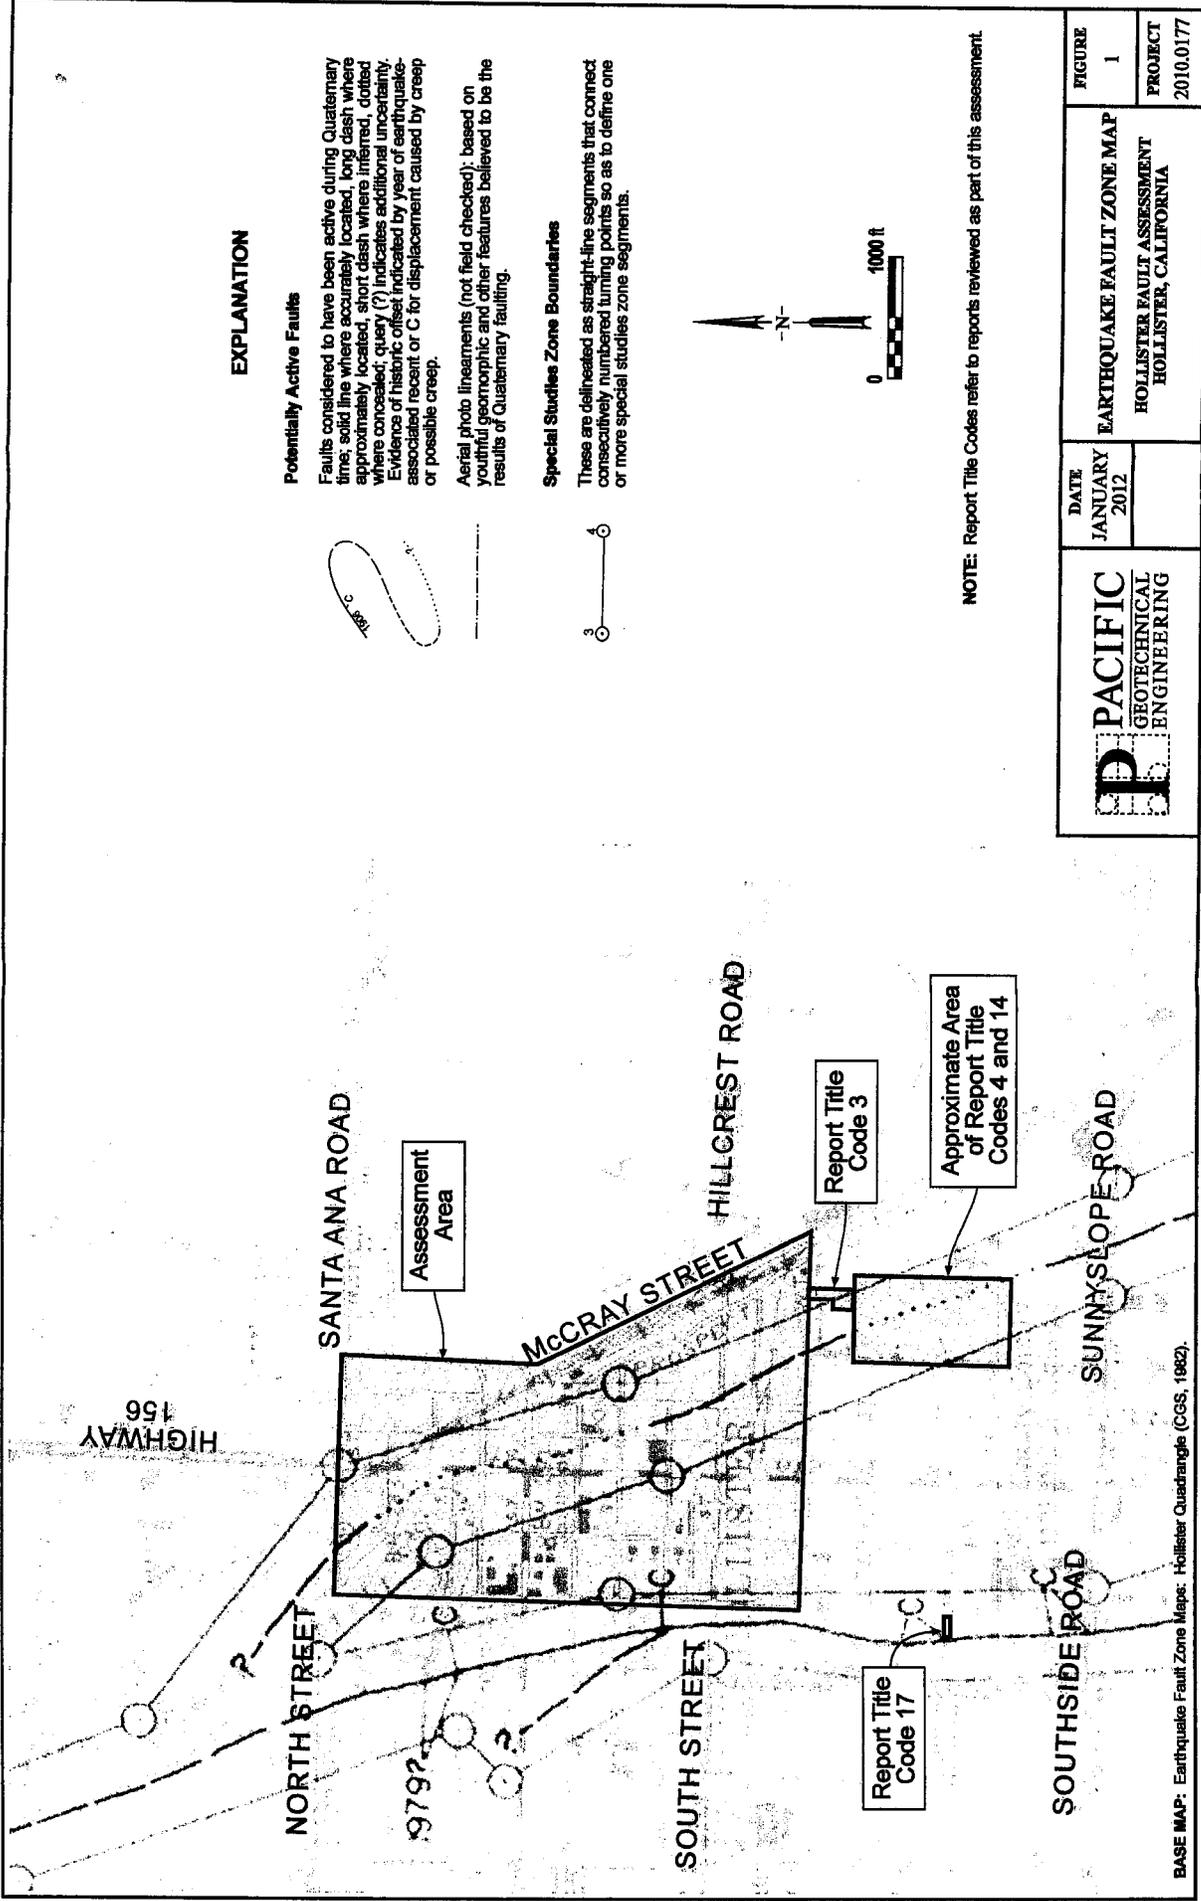
DATE	FIGURE
	JANUARY 2012	1
EARTHQUAKE FAULT ZONE MAP HOLLISTER FAULT ASSESSMENT HOLLISTER, CALIFORNIA		PROJECT
		2010.0177

NOTE: Report Title Codes refer to reports reviewed as part of this assessment.

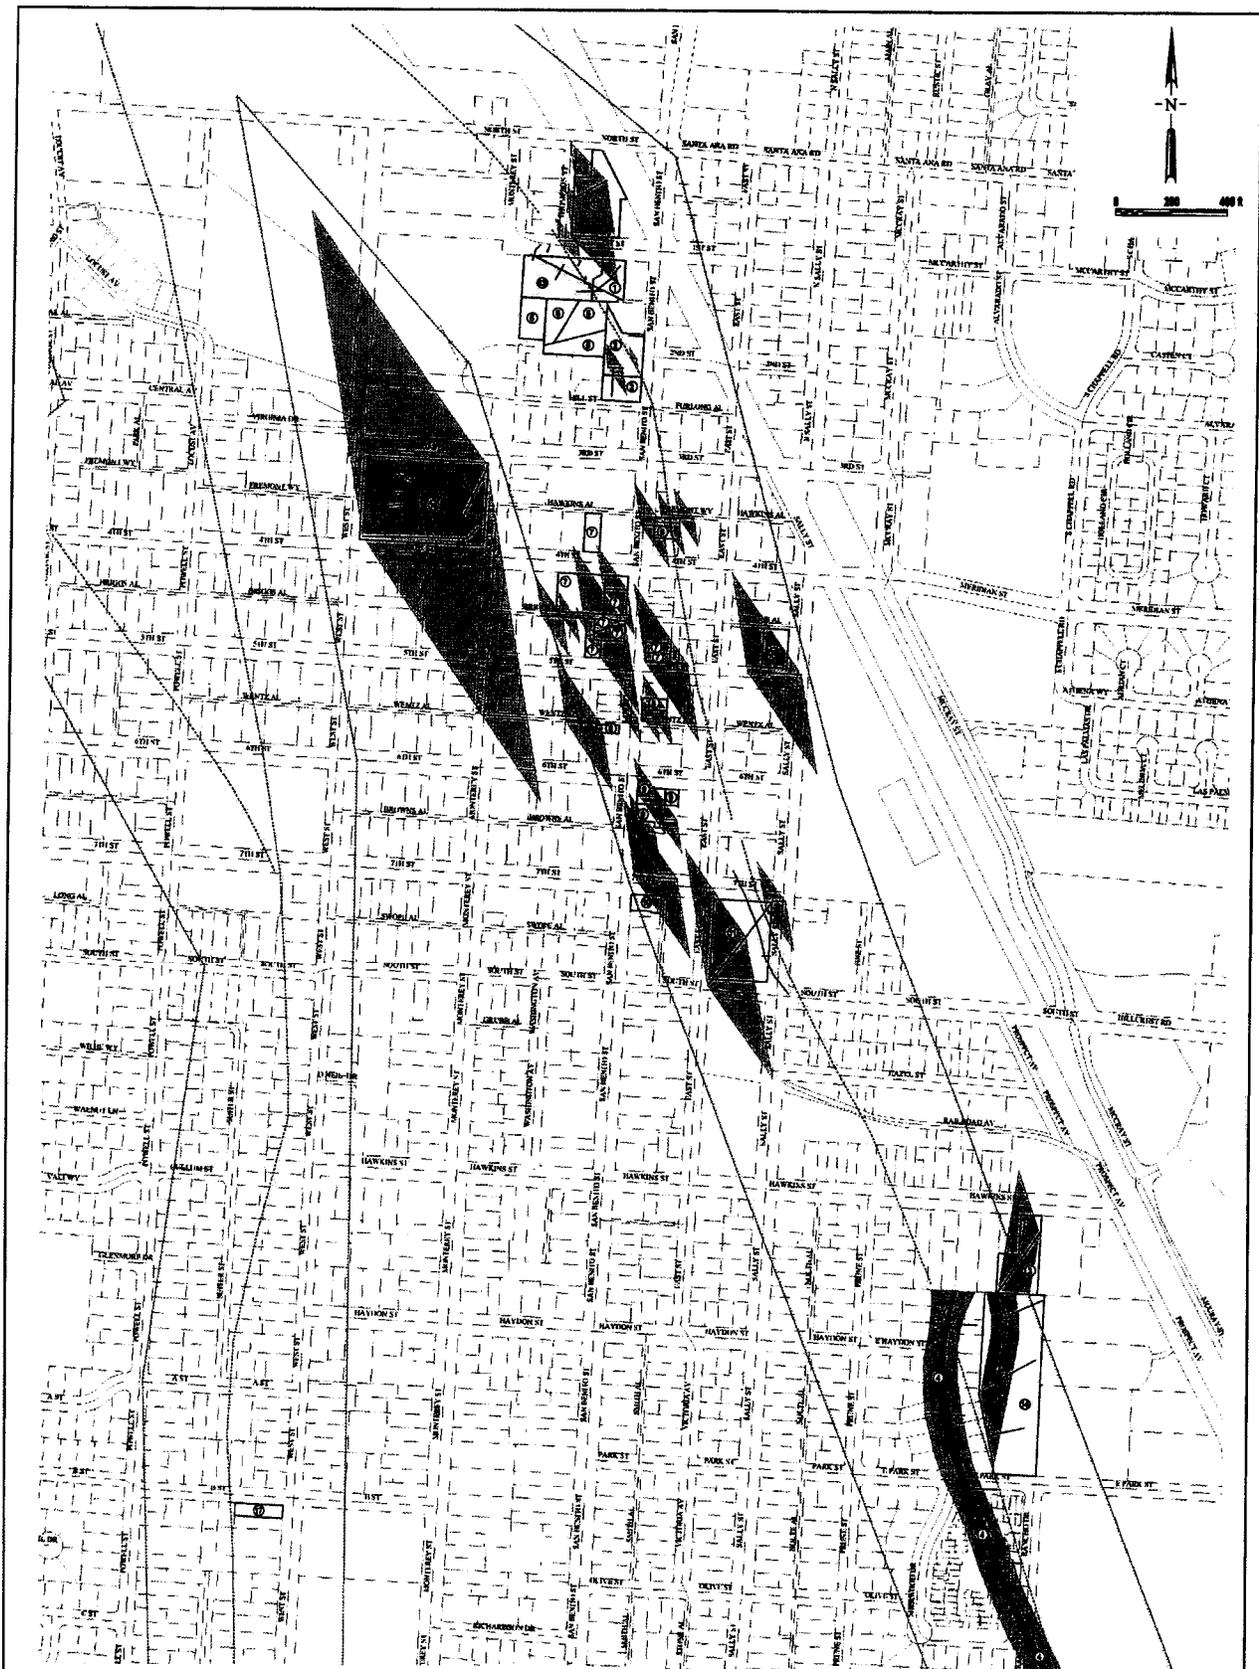
<b>PACIFIC</b> GEOTECHNICAL ENGINEERING	DATE JANUARY 2012	<b>FAULT HAZARD MAP</b> HOLLISTER FAULT ASSESSMENT HOLLISTER, CALIFORNIA	FIGURE 2
			PROJECT 2010.0177

Map features compiled as part of our assessment are presented in paper format as Figure 2 of this report, which uses the San Benito County GIS "parcel" and "street centerlines" layers as a base map. The map features presented on Figure 2 have been modified (color, shading, and line-weight changed) for clarity and presentation with this report. These features will appear as simple line, area, and point features in the digital dataset included on the CD accompanying this report. It is anticipated that color, shading, and lineweight modifications will be made at the discretion of the City once the data is merged with the City (County) GIS database.

- No faulting has been identified between Seventh Street and the approximate area of First Street. Although most of the trenching has been conducted west of the State-mapped fault trace, at least one investigation (Report Title Code 6, 335 San Benito Street) trenched directly across the mapped CGS trace with no discovery of a fault.

The conspicuous absence of documented Holocene faulting between Seventh Street and the approximate area of First Street may be due to any number of reasons. Most of the trenching completed to date has been conducted in the western portion of the EFZ, leaving room for the fault to pass through the eastern half of the EFZ. However, based on the geologic observations noted above, we suggest that the fault is likely buried, or simply dies out northward, in this part of downtown Hollister.

Based on the compilation work conducted as part of this study, and our generalized approach to property clearance, we suggest that a select portion of the downtown assessment area presents a likely candidate for blanket clearance of multiple properties of fault rupture hazard. This target area is roughly bounded by the State-mapped trace of the East Branch Calaveras fault on the east, the western edge of the East Branch Calaveras EFZ boundary on the west, Fourth Street on the north, and Sixth Street on the south. The closely-spaced distribution of exploratory trenches and associated "cleared" polygons in this area makes the probability of a through-going fault in this area highly unlikely. While there are some narrow gaps between trenches and cleared areas, the probability that a fault passes through all of them is judged to be low. We preliminarily suggest that this area be considered as potential ground that could be cleared of fault rupture hazard with little or no further exploratory trenching.

The area west of the CGS-mapped fault trace between Sixth and South streets also has a closely-spaced distribution of trenches and associated "cleared" polygons, making it another likely candidate for property clearance. We also suggest that the adjacent trenches and

associated "cleared" polygons at Fremont Way and San Benito Street could be linked to form a larger area of "cleared" ground (Report Title Code 6).

One of the best opportunities to efficiently and strategically clear additional ground in the downtown area is present along Fifth Street, which passes directly through the aforementioned target area. Between San Benito Street and East Street, nearly half of the block along Fifth Street has been trenched, with no fault found (Applied Soil Mechanics, 1991; Report Title Code 7). Between East and Sally Street, a significant portion of the block was recently trenched for the City of Hollister Fire Station No. 1 project (Earth Systems Pacific, 2010; Report Title Code 16) with no faulting identified. Supplemental trenching between these two studies across East Street would have the potential to clear nearly two thirds of the width of the East Branch Calaveras EFZ along Fifth Street with continuous trench.
