Brigantino Park

Landscape Irrigation Evaluation

Project: Brigantino Park
Location: City of Hollister

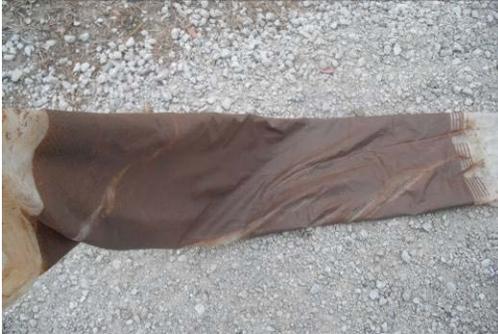
- The debris in the recycled water from the sewage plant causes equipment failures two to three times a month stopping delivery of water to the park resulting in dry spots in the turf. Debris also clogs the gear assemblies of the Toro TR70P rotors preventing them from rotating. Toro TR70P rotors cannot be cleaned and must be replaced when clogged. Consider installing a filtration system that can better handle the amount of debris in the water. Or try identifying the debris and further treat the water accordingly at the sewage plant in order to dissolve the debris to prevent further equipment failure and loss of turf due to inadequate coverage and water supply.

Replaced Filter after One Week of Use

Based on the condition of the landscape at Brigantino Park caused by equipment failure due to debris in the recycled water, it is recommended that the filtration system is improved or more extensive methods for treating the water are put in place to allow for a more reliable source of water. Also, improving the distribution uniformity of the irrigation system will allow the recycled water to be applied evenly to the required depth of 18 inches.

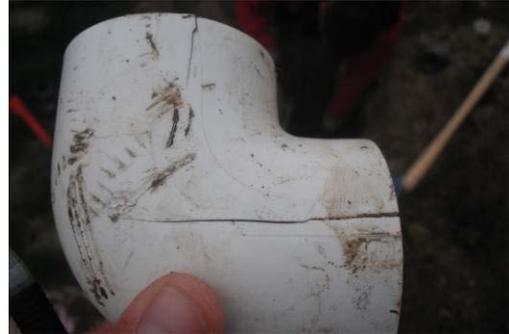
- PVC fittings split due to excessive water pressure. Static water pressure averages 80 PSI and can rise to 90 PSI. Six valves have failed due to this problem since installation. Consider using pressure regulating “dirty water irrigation control valves” for recycled water in place of Irritrol valves. Also, some PVC fittings and Schedule 80 nipples appear to have been overly tightened at the time of installation, which combined with high water pressure are causing PVC fittings to crack on the irrigation mainline.

Split PVC 90° Angle Caused by High Water Pressure

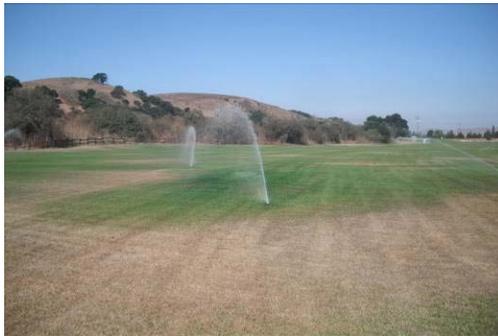
- Stations #33, #47, and #49 – Some sprinklers do not rotate due to the amount of debris clogged in the gear assemblies and should be replaced immediately to prevent loss of landscape.

Dry Spots due to Lack of Coverage & Clogged Rotors Not Rotating

- Consider checking all stations one by one to correct any low, tilted, or clogged sprinklers that are not rotating. This can be achieved over a period of time depending on budget expenditures.

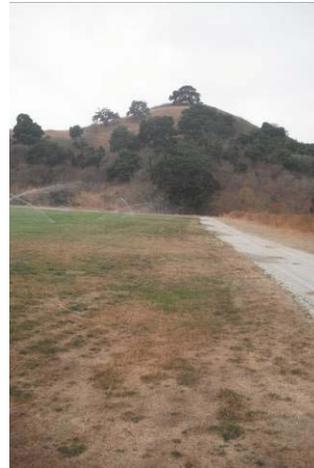
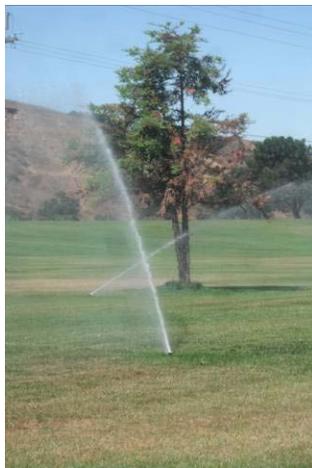
Rotor Blocked by Tree

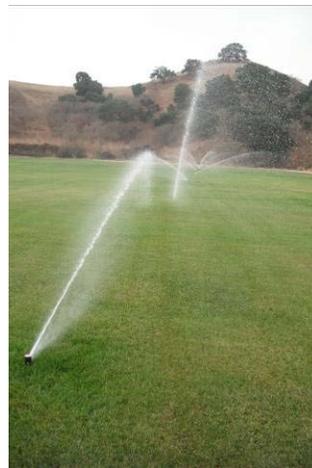
Tilted Rotor

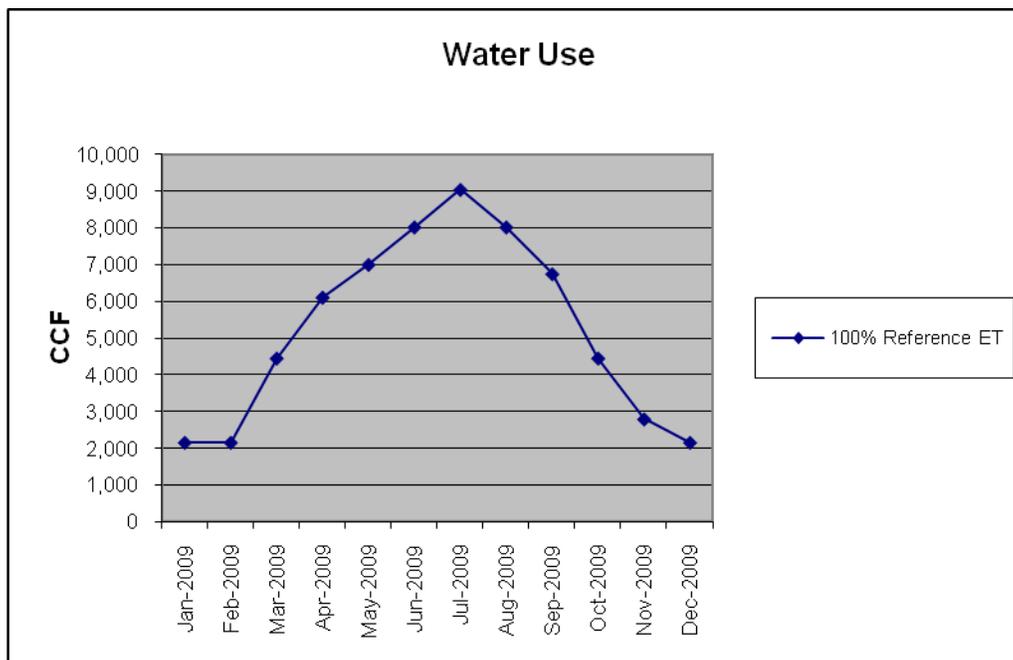
Recommended CCF amounts located on Page 10 in Table 2 and Figure 2 can be used as an irrigation budget for each month. Recommended amounts were determined at 100% reference ET and an 18 inch root depth. Based on four meter readings per month, on site staff will be able to adjust irrigation schedules accordingly to fall within the recommended monthly CCF. Provided as Attachment 1, please find schedules for Toro Clock, Stations #3, #17, #34, and #44. Once schedules are implemented, additional sprinklers may need to be added to increase distribution uniformity. Once controllers are adjusted according to meter readings, it is necessary to visually inspect landscaped areas to assure that all areas receive adequate water. This may require additional adjustments to each station or possible renovation of the irrigation system.
